October 14, 2008

**Subj:** ArgoNeuT Recirculation Line Modification

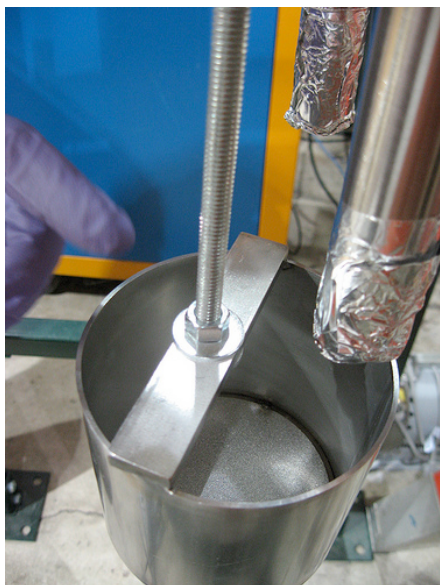
The "stinger" (the single wall line coming down from the filters) is terminated in the gas volume on top of the liquid surface, at a temperature presumably rather high. The purified liquid drips out of the stinger and into the "cup" (with sintered metal bottom) partially immersed into the liquid.

Some effects could prevent an efficient LAr recirculation:

1. **Dirty Gas Argon** (in the GAr volume, contaminated by the outgassing of the warm walls, cables, plastic supports, ...), at the saturation Pressure imposed by the Set Point of the cryo-slow control, **fills the return line up to the Purifier (at LAr Temp)**. It tends to move in the opposite direction against the recirculation loop, presumably lowering its flow rate.

2. **Part of this Dirty Gas Argon gets liquified inside the stinger and coming back into the LAr volume may contaminate it** (more effectively than by natural diffusion from the gas into the liquid).

3. **Part of the Purified Liquid Argon from the Purifier gets evaporated while dripping out (and inside) the stinger into the cup, and does not (or only marginally) contribute to the LAr purification process.**

4. **Only the fraction of Purified Liquid Argon that reaches the LAr volume contributes to its actual purification. This fraction of the Purified Liquid Argon is released near the liquid**

**surface and may evaporate into the GAr volume before diffusing inside the LAr volume (lowering in this way the efficiency of the purification loop).**

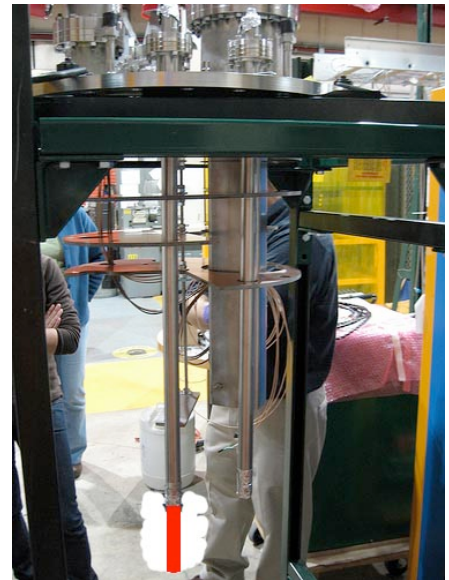
- to remove the cup and just extend the return line (purified LAr from the purifier) by ~10 inch. (or more if possible) up to have the end of it well immersed into the liquid. In this way pb.s (1 to 3) should be solved and only pb.(4) could remain only partially solved.

The question is how to seal the extension line (“~10 inch. pipe”) to the end of the existing line. The easiest way could be by using a straight tube fitting with two side connection (e.g. Swagelock [Tube Fittings - Straights](#) | [Connection 2 Size : 1 inch](#) shown in in Figure [Left]).

Alternatively by threatening the ends of the existing line (stinger) and of the “10 inch. pipe” and screwing the one into the other.

This “intermediate solution” doesn’t require the pipe to be extended to the bottom of the cryostat (complicated design/ welding) but should provide more efficient recirculation of the liquid.

The “ion formation” should be avoided with this type of solution, in any case the “10 inch. pipe” also could be terminated at the immersed end with a sintered disk.
